## VLC Annual Inspection V3

### Palfinger Australia

Identifier	100158060 ML
------------	--------------

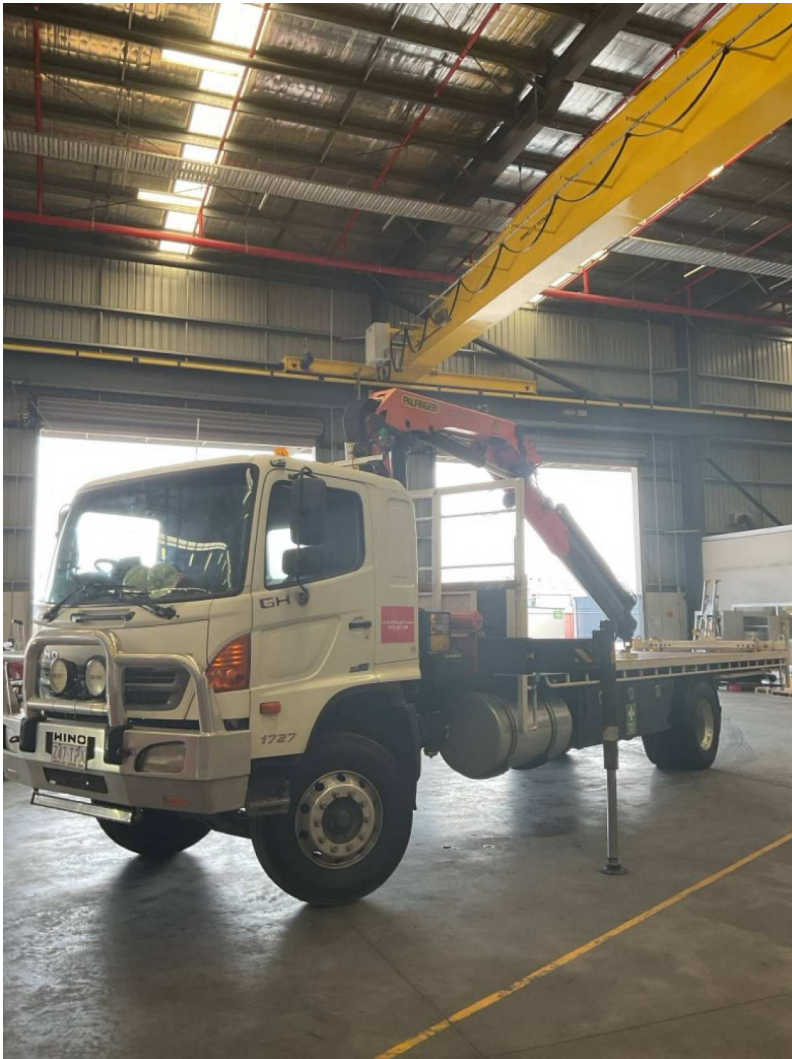
Photo Appendix 1

Vehicle	Attachment text: Hino
---------	-----------------------

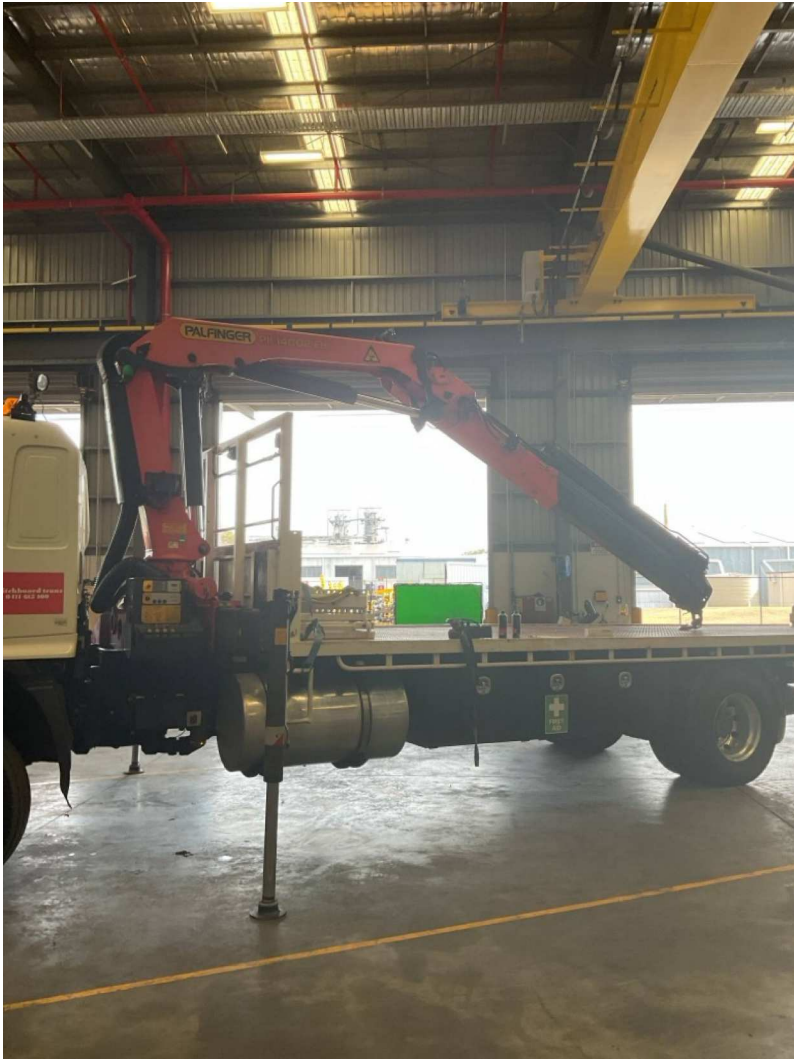
Photo Appendix 2

Crane	Attachment text: Pk14002
-------	--------------------------

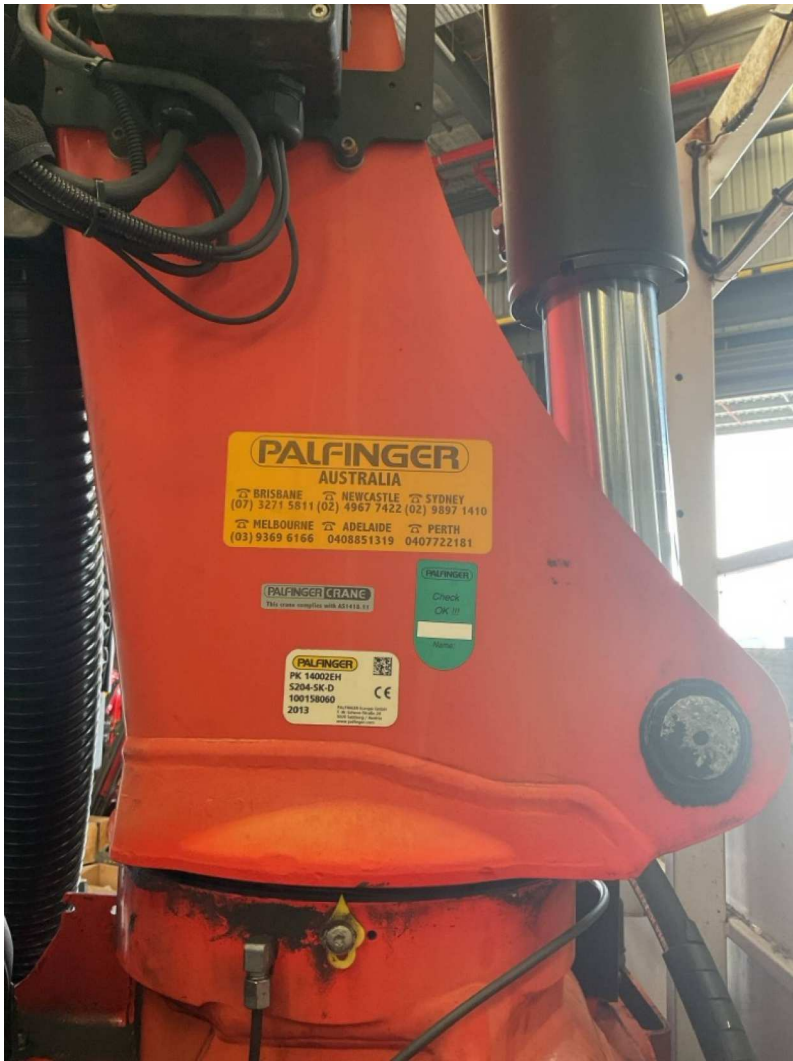
Photo Appendix 3

<b>VLC Serial Number Tag</b>

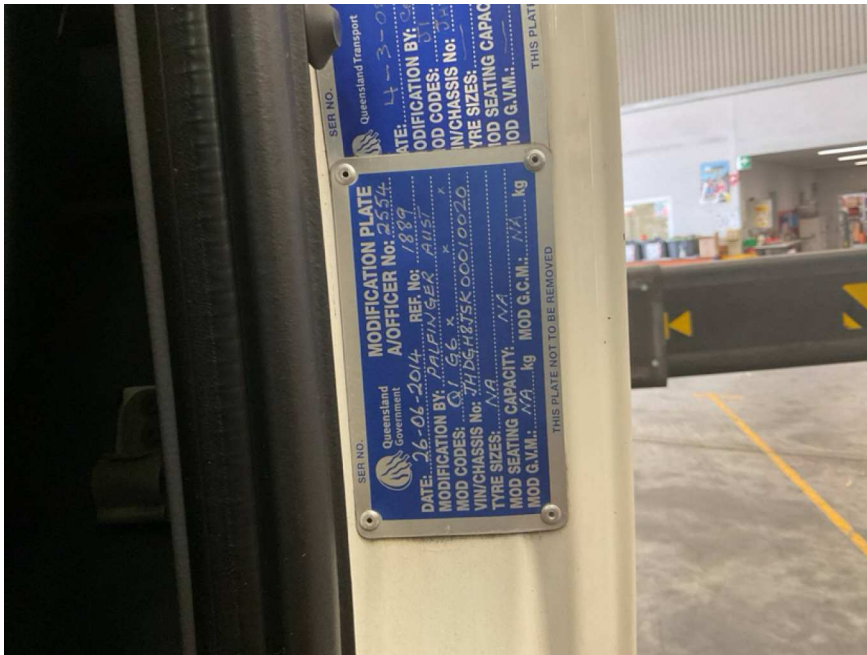
Photo Appendix 4

Customer has stated 10 year inspection has been completed, no inspection plate on crane or truck.
